The Central Valley Project and State Water Project

Major Facilities

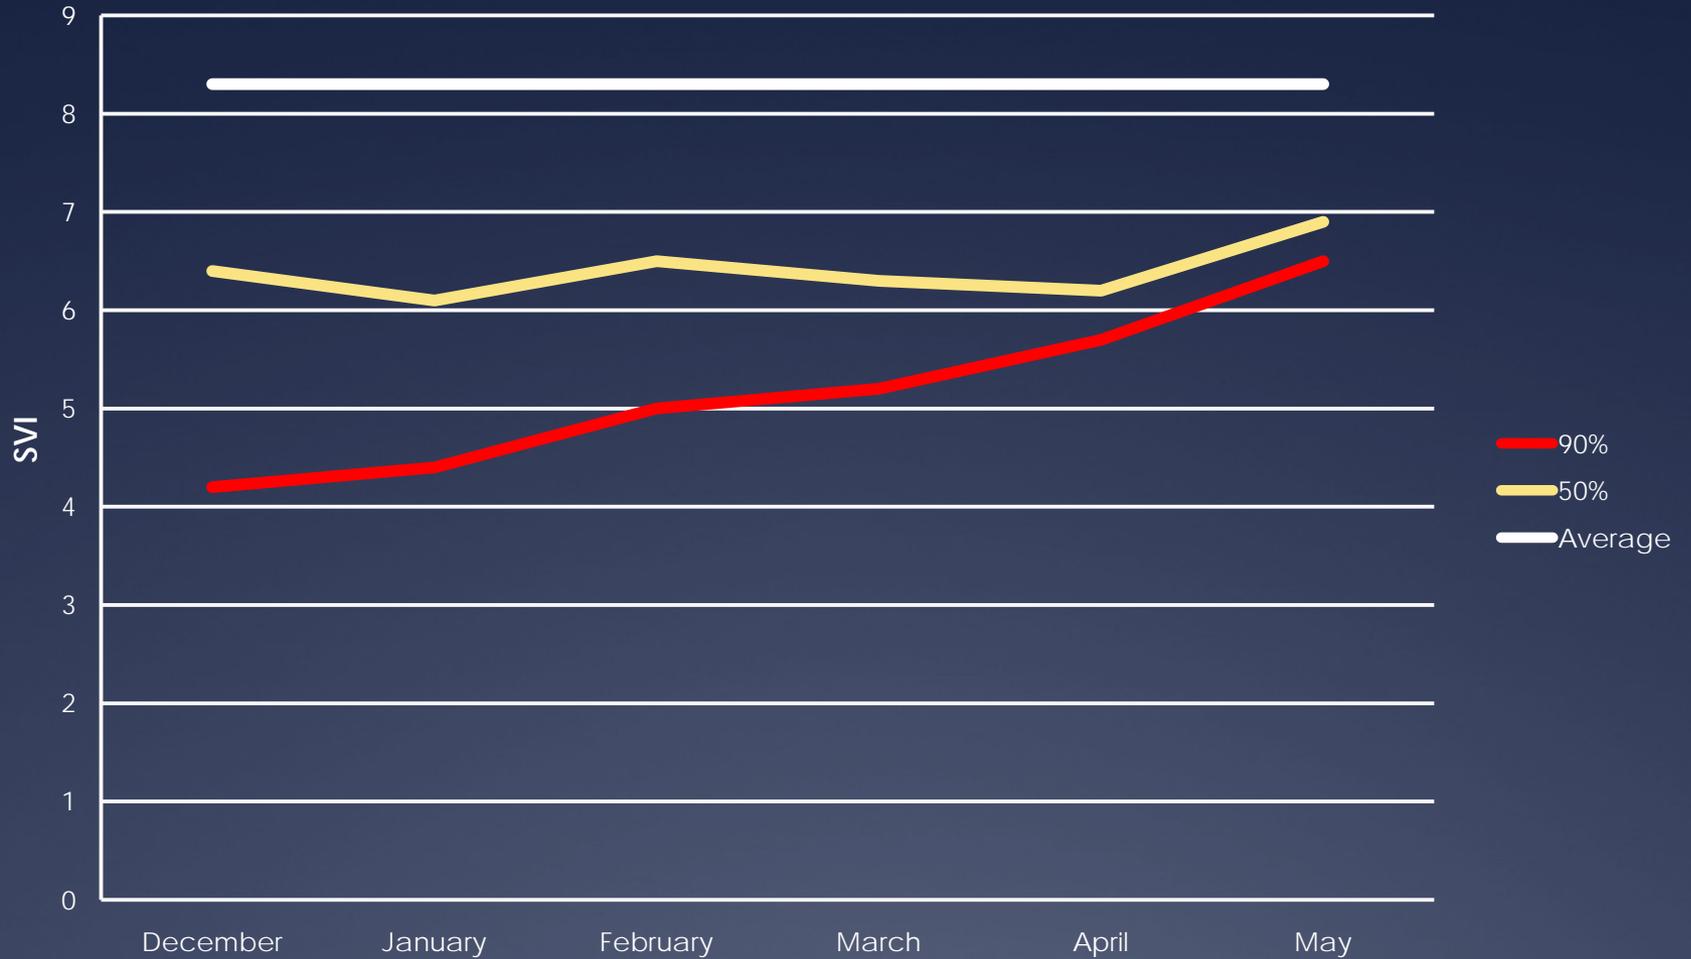
Forecasted Sacramento Valley Index

December 2009 to May 2010

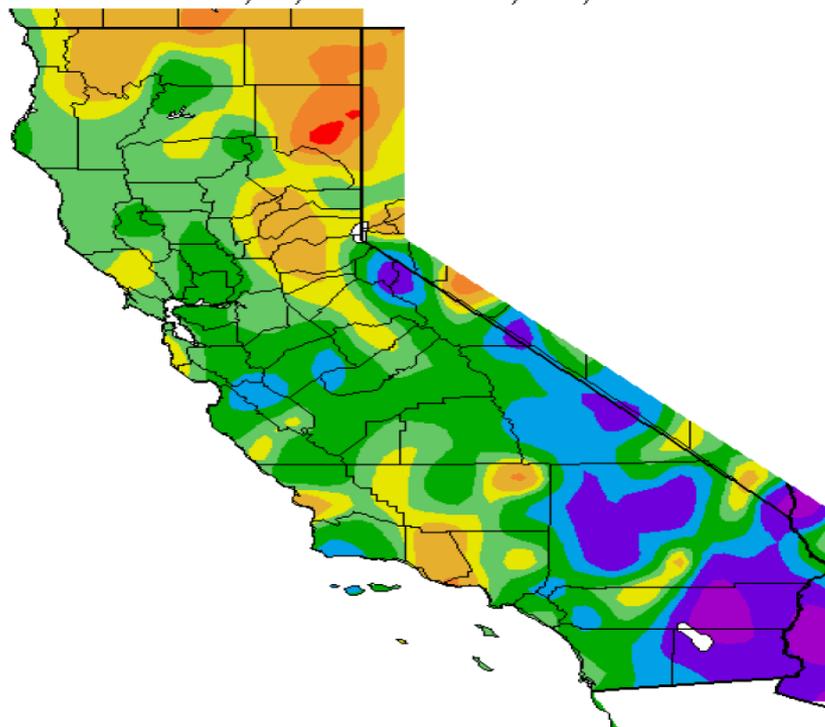
Latest Northern Sierra 8-Station Index (as of 17 May 2010):

April = 8.2" = 210%

May = 1.2" = 57%

Season = 50.1" = 107%

WY = 100%

Last year to date = 45.1" (88%)

May 2009 = 5.5" (260%)
